Barataria Bay Waterway West Side Shoreline Protection Summary Data and Graphics

Barmore, J. 2003. *BA-23 Barataria Bay Waterway West Side Shoreline Protection Summary Data and Graphics*. Louisiana Department of Natural Resources, Coastal Restoration Division, Baton Rouge, Louisiana 32pp.

BA-23 Barataria Bay Waterway West Side Shoreline Protection

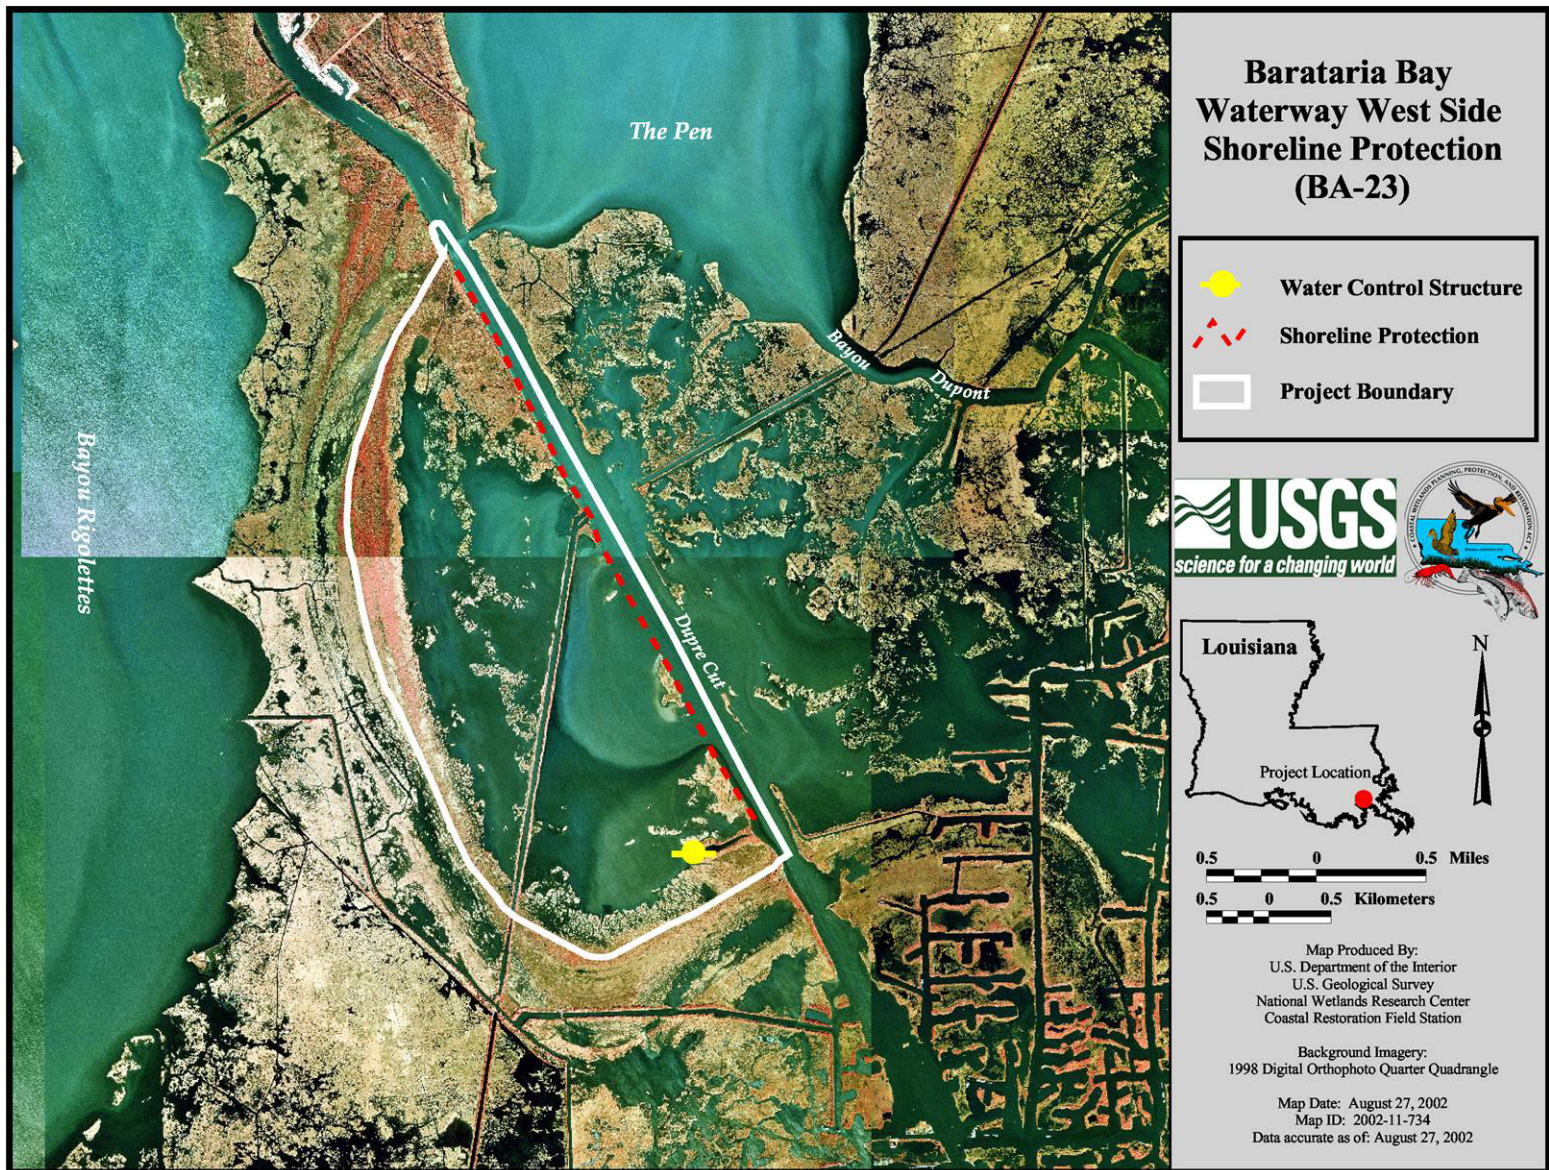
- The BA-23 project consists of approximately 9,400 linear feet (2,865 m) of rock bankline protection (foreshore rock dike) along the west bank of the Barataria Bay Waterway (BBW) to protect the adjacent marsh from excessive water exchange and erosion from boat wakes. (Figure 1.)
- In addition, the U.S. Army Corps of Engineers (USACE) placed 750,000 cubic yards of dredged sediments from their BBW dredging operation behind the rock dike to fortify the shoreline, create new marsh, and to form a continuous protection levee.
- A water control structure was built on the southern end of the project area to allow control of water level during hunting season and still allow for the passage of marine organisms. (Figure 1.)
- Construction was completed on November 15, 2000

Figure 1. Barataria Bay Waterway West Side Shoreline Protection project boundaries and features.

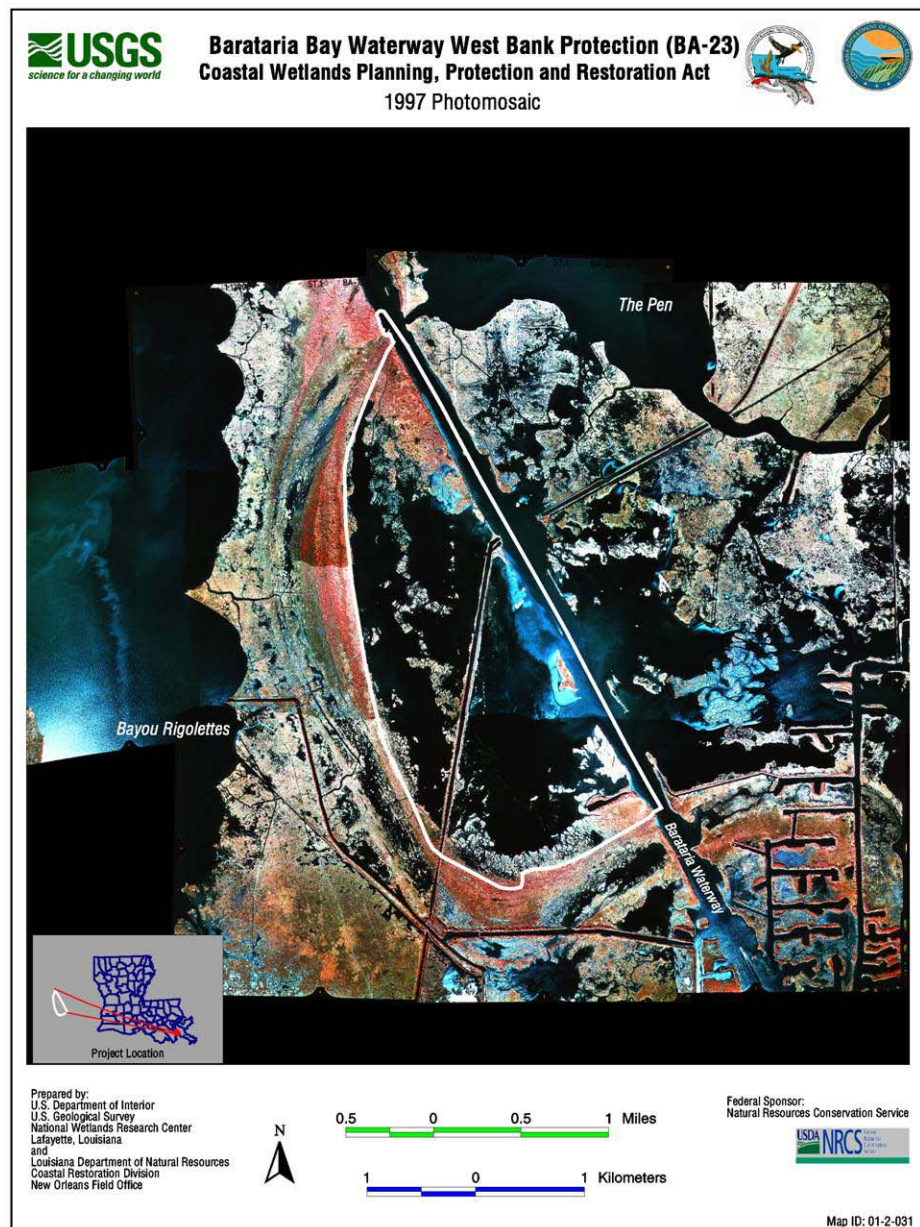
Figure 2. 1997 Photomosaic of the Barataria Bay Waterway West Side Shoreline Protection project.

- 1997 Photomosaic (Figure 2.)
- 1997 Land-Water analysis (Figure 3.)

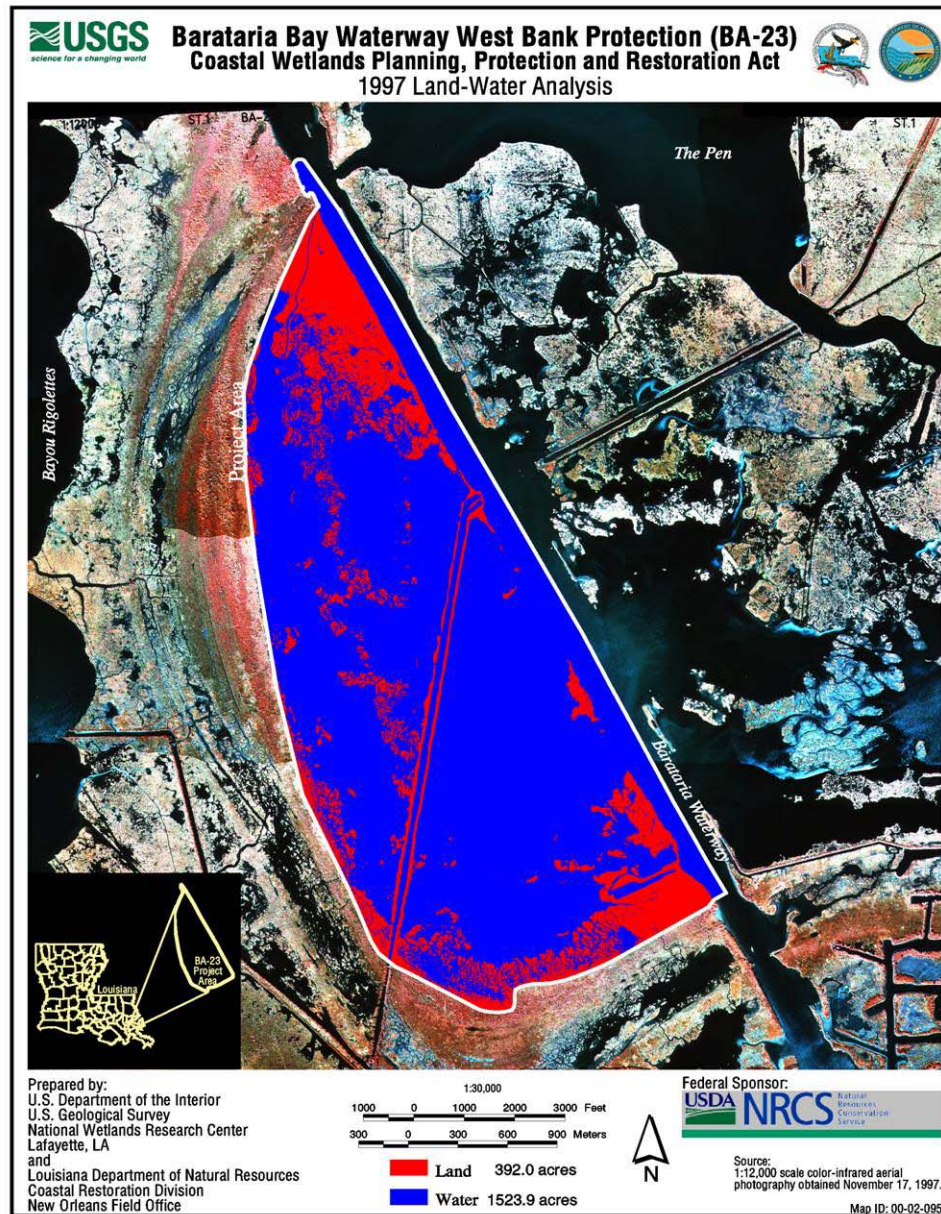
Figure 3. 1997 Land-Water analysis of the Barataria Bay Waterway West Side Shoreline Protection project.

- Aerial surveys identified 392.0 acres of land and 1523.9 acres of water (Pre-construction – 1997).

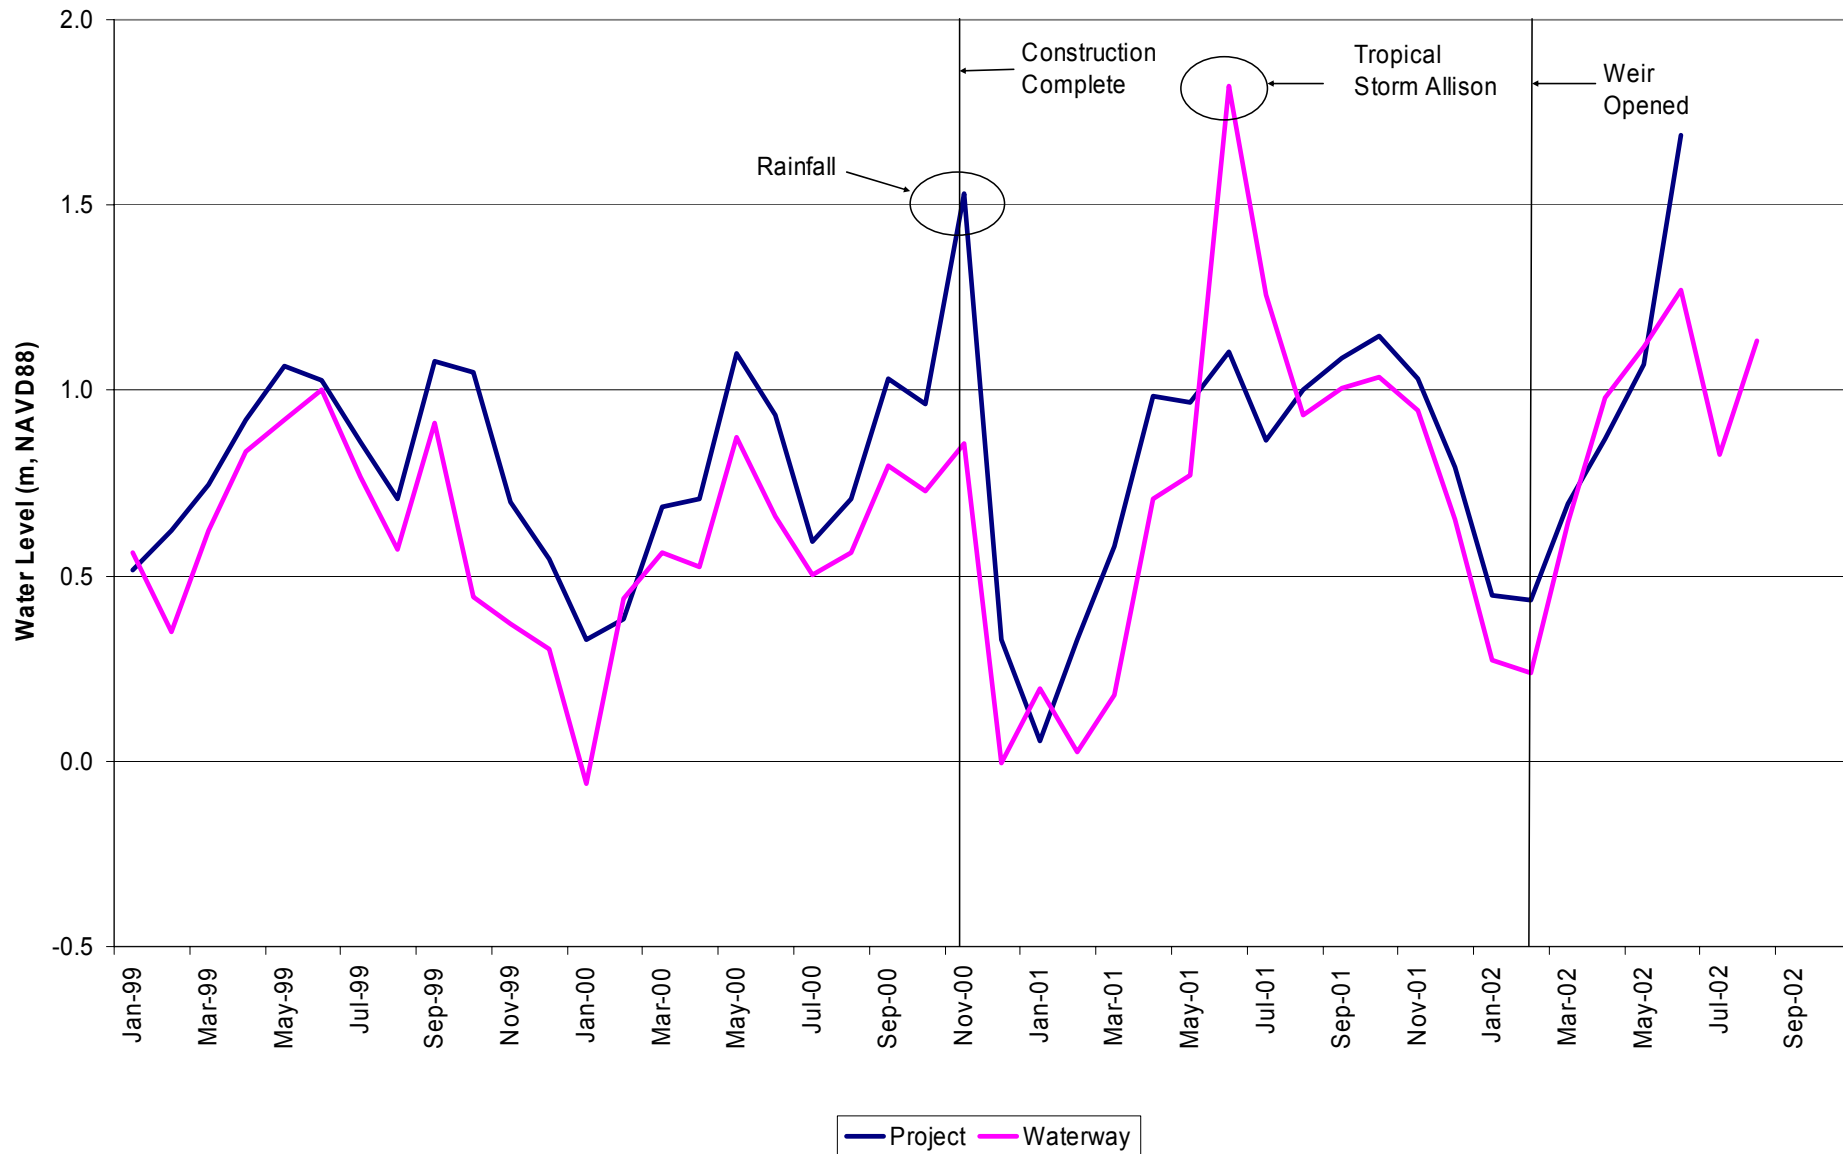
Monthly Average Water Level Measured at the Barataria Bay Waterway West Side Shoreline Protection Project (BA-23) from January 1999 - July 2002

- Daily and Monthly water levels as well as variability have not significantly decreased, but this may be due to less than one year of post weir data analysis.

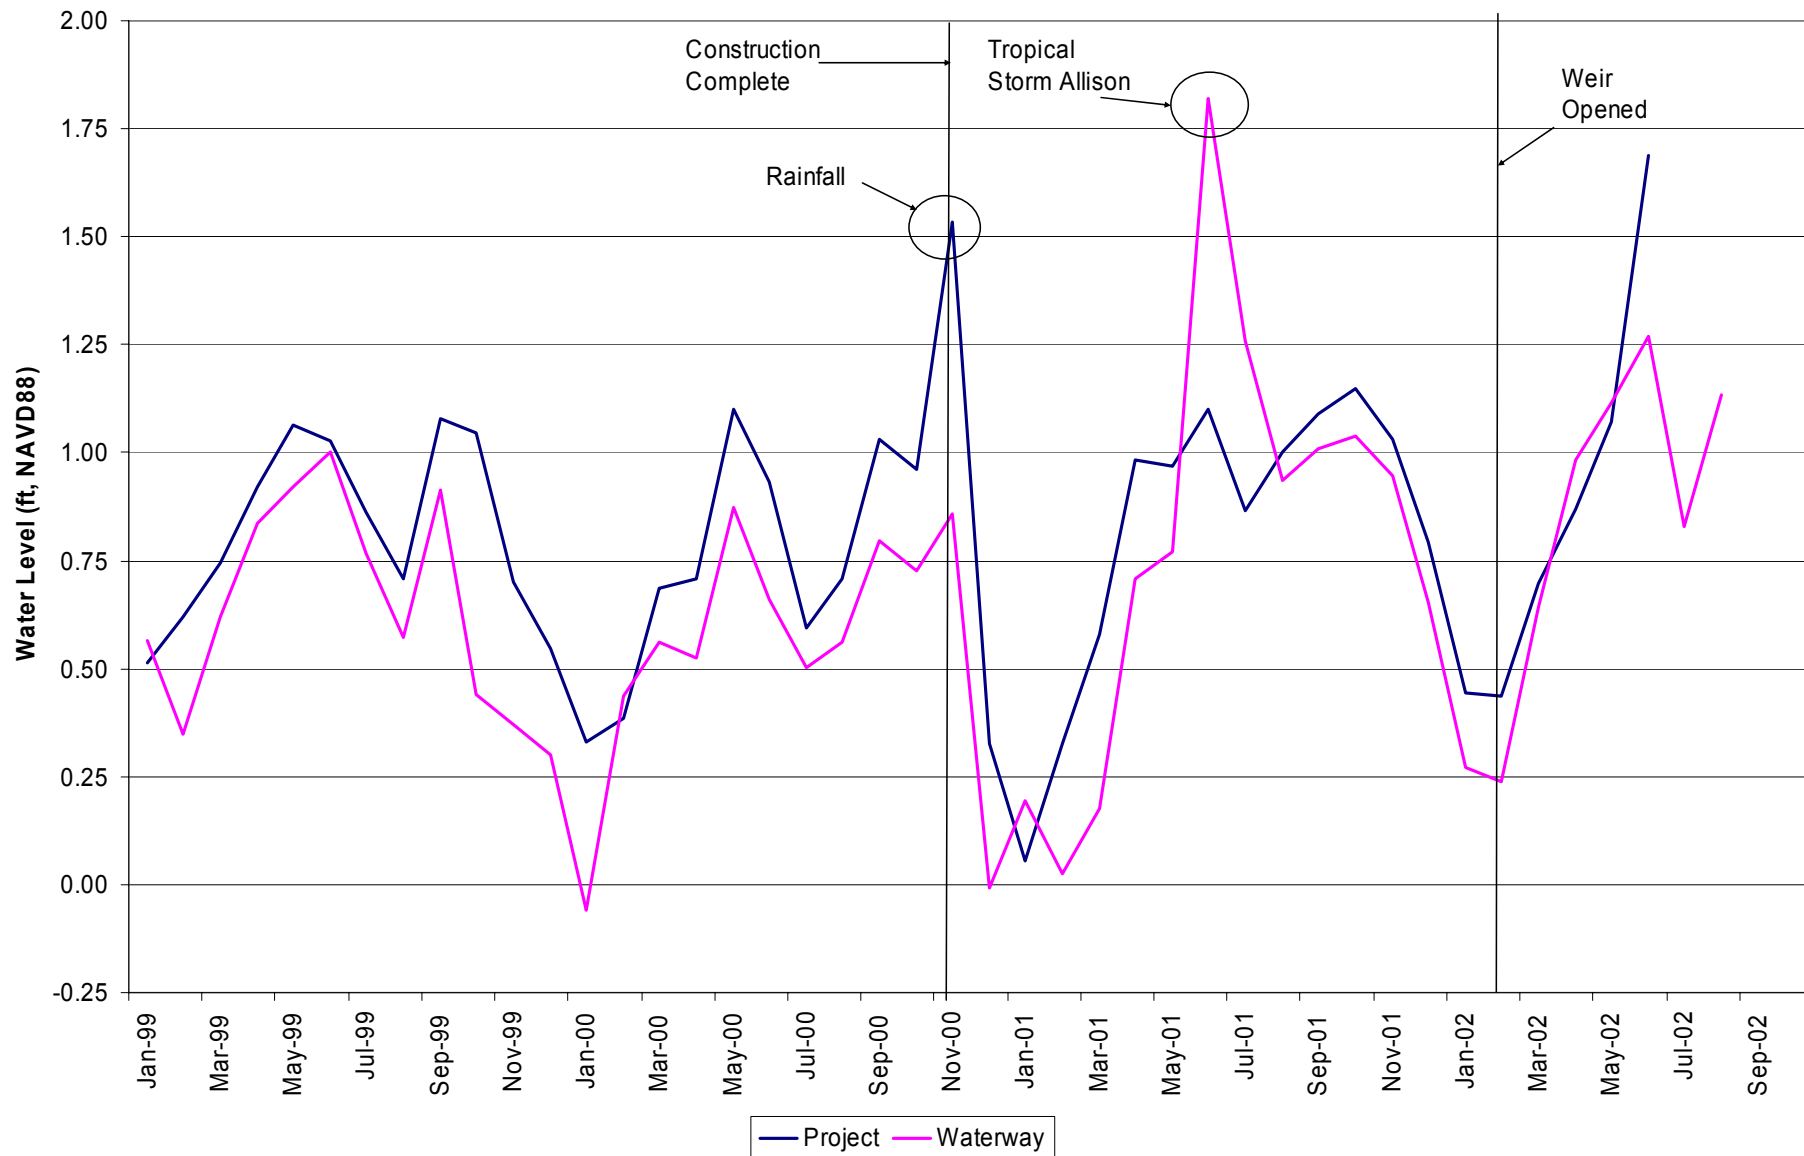
Monthly Average Water Level Measured at the Barataria Bay Waterway West Side Shoreline Protection Project (BA-23) from January 1999 - July 2002

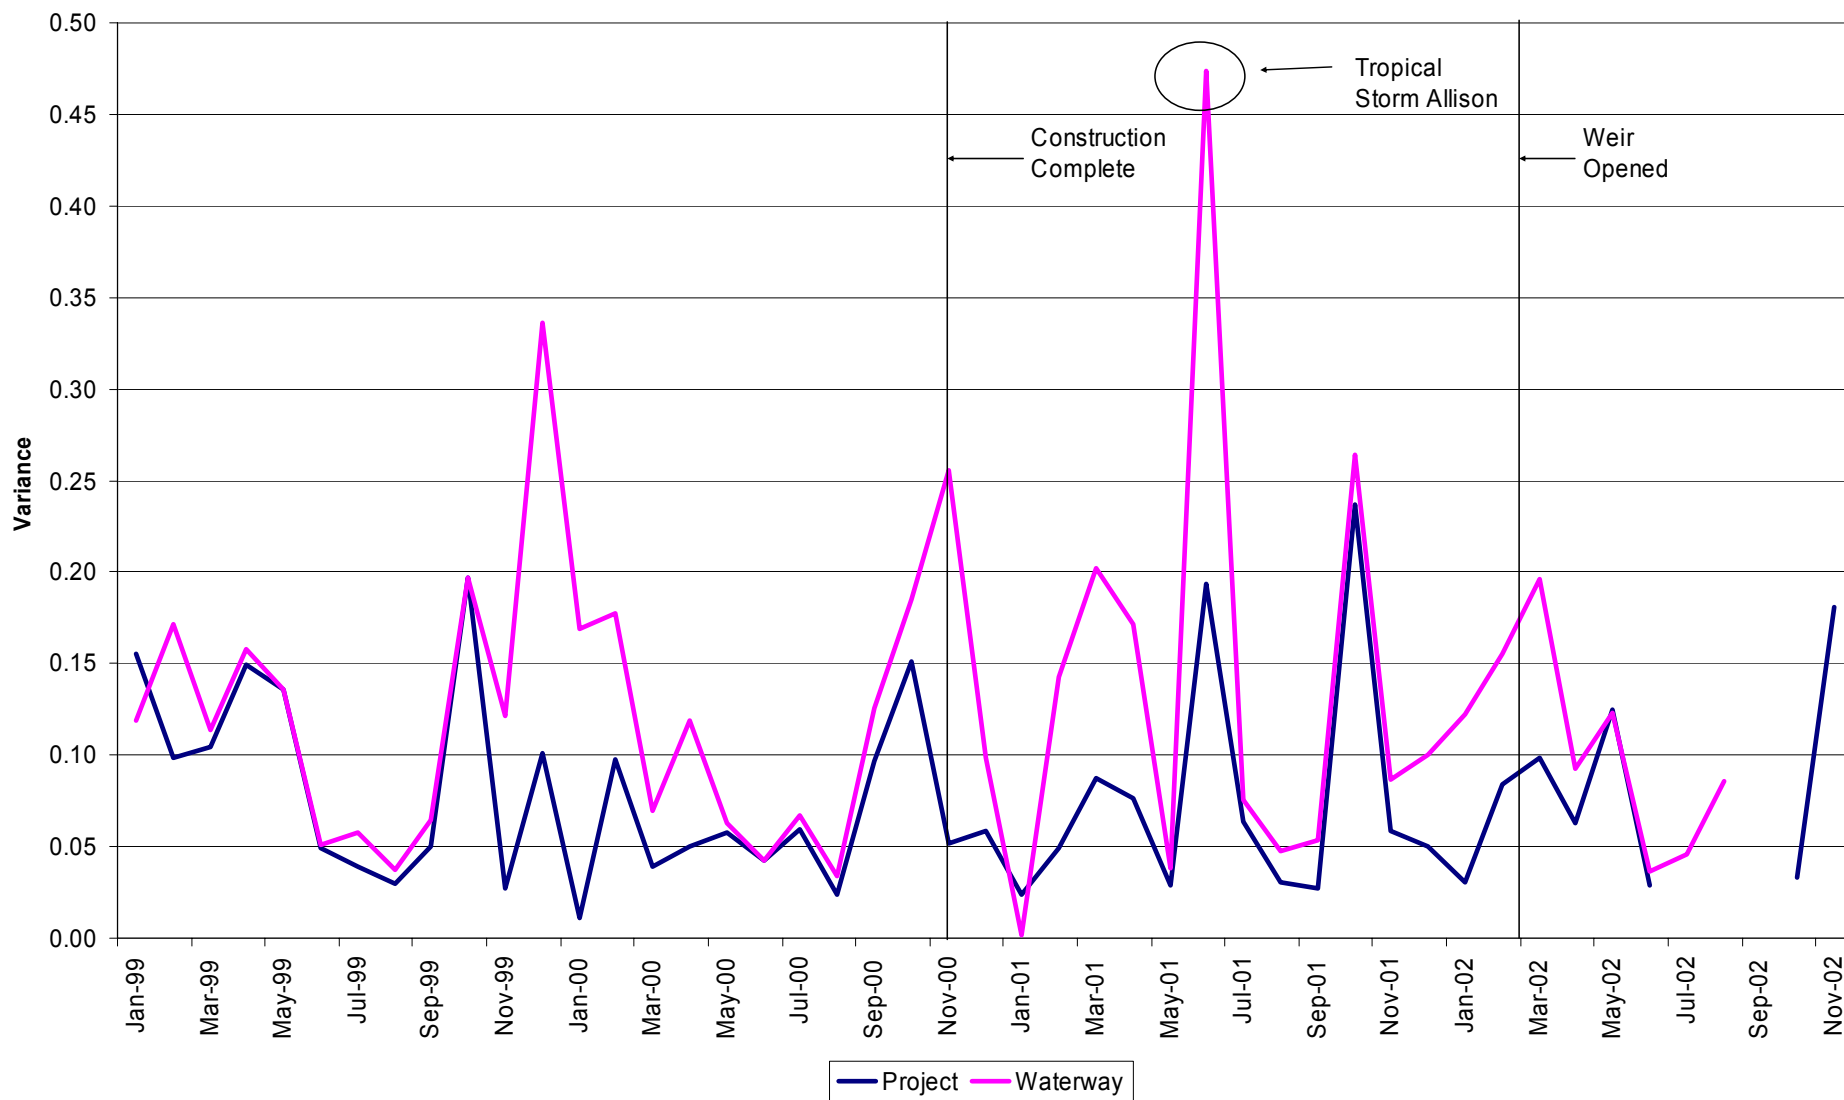
Monthly Variance in Water Level Measured at the Barataria Bay Waterway West Side Shoreline Protection Project (BA-23) from January 1999 - July 2002

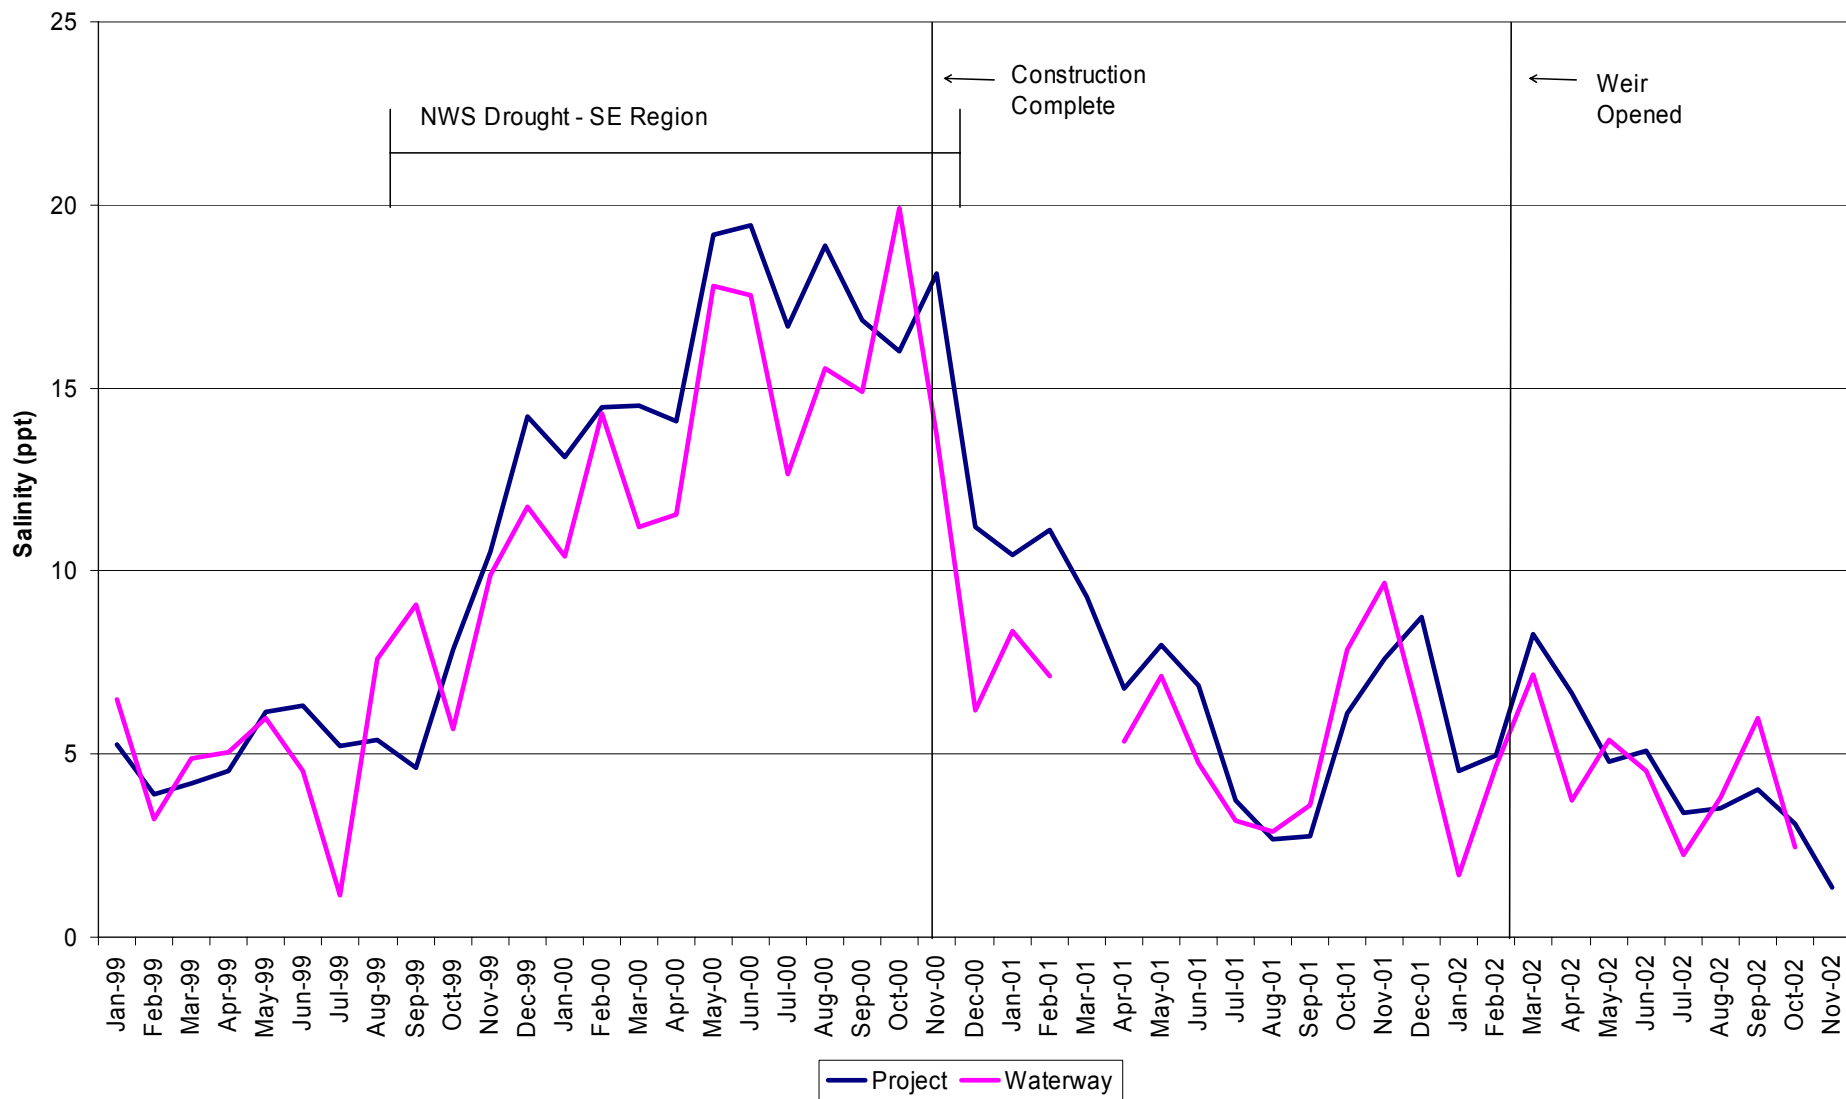
Monthly Average Salinity Measured at the Barataria Bay Waterway West Side Shoreline Protection Project (BA-23) from January 1999 - July 2002

- Daily and Monthly salinity levels as well as variability have not significantly decreased, but this may be due to less than one year of post weir data analysis and a drought that coincided with the completed construction.

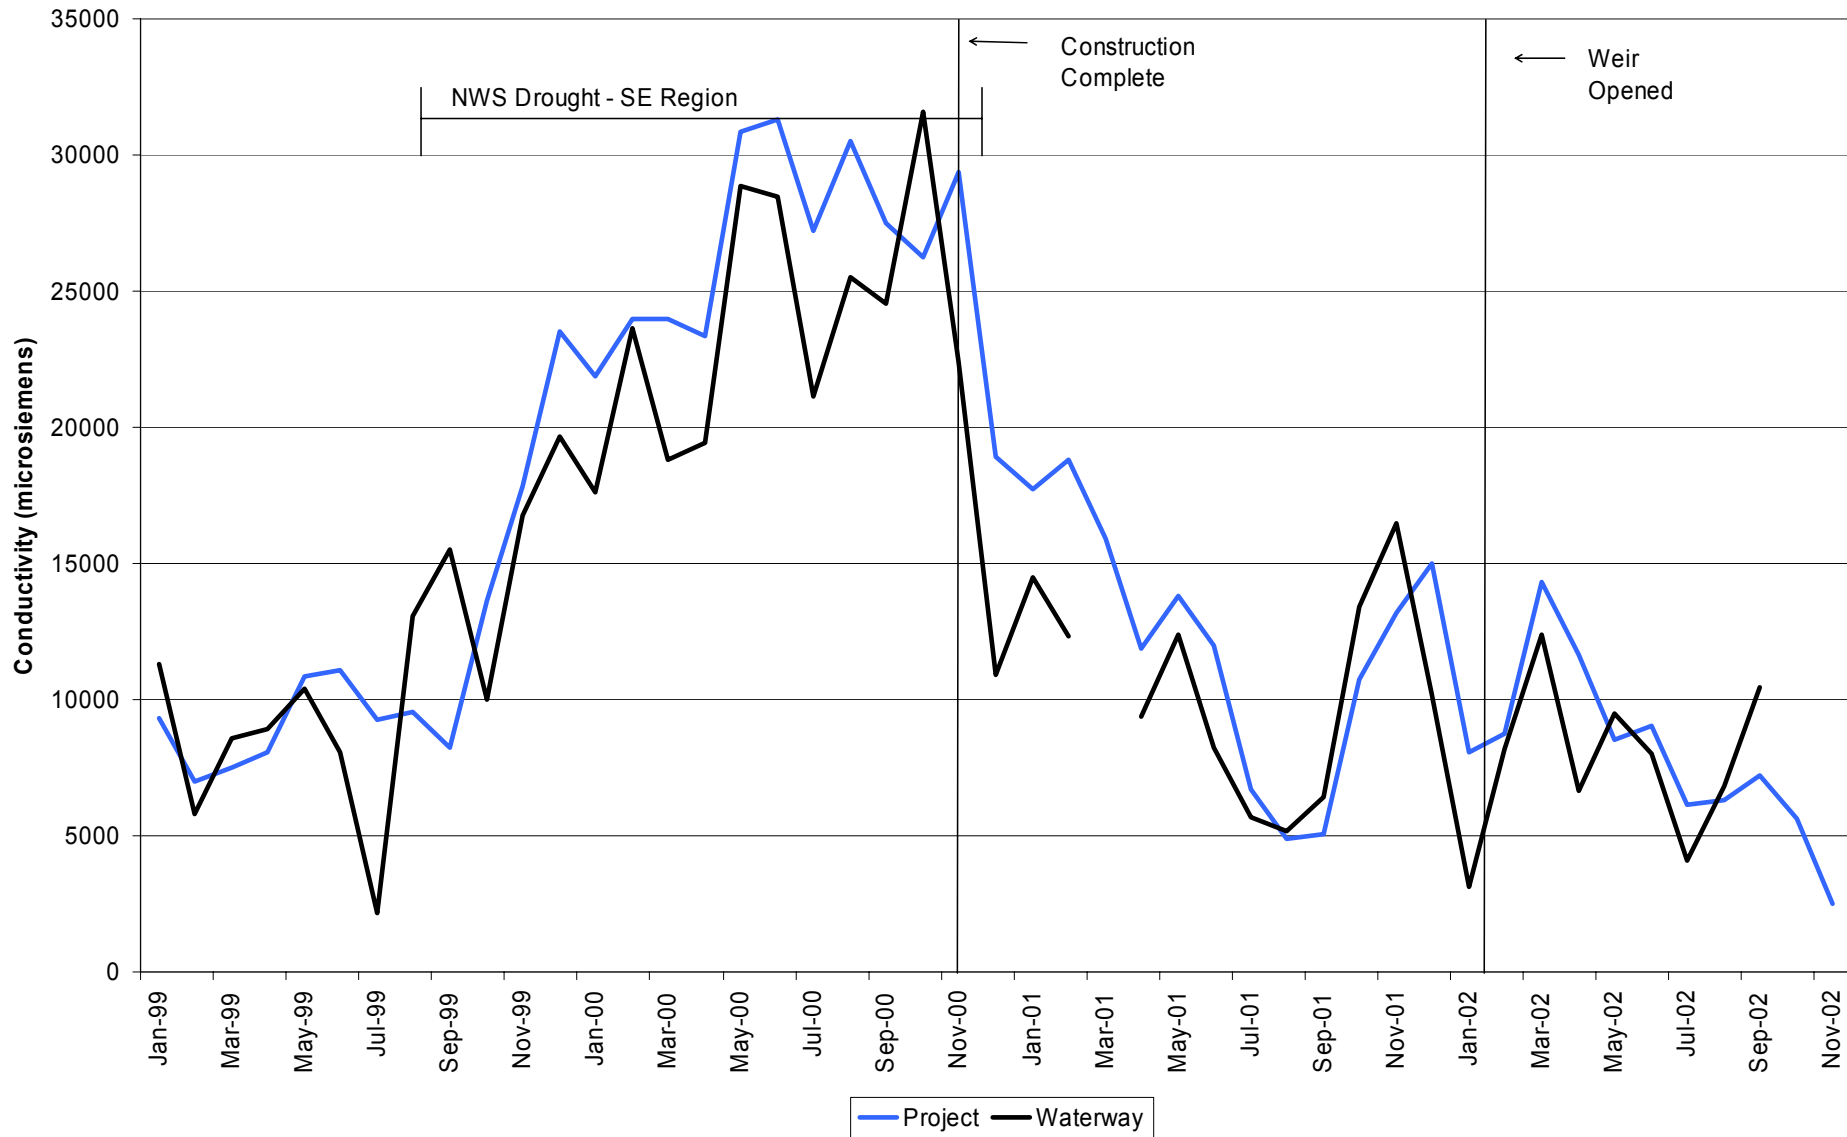
Monthly Average Specific Conductance Measured at the Barataria Bay Waterway West Side Shoreline Protection Project (BA-23) from January 1999 - July 2002

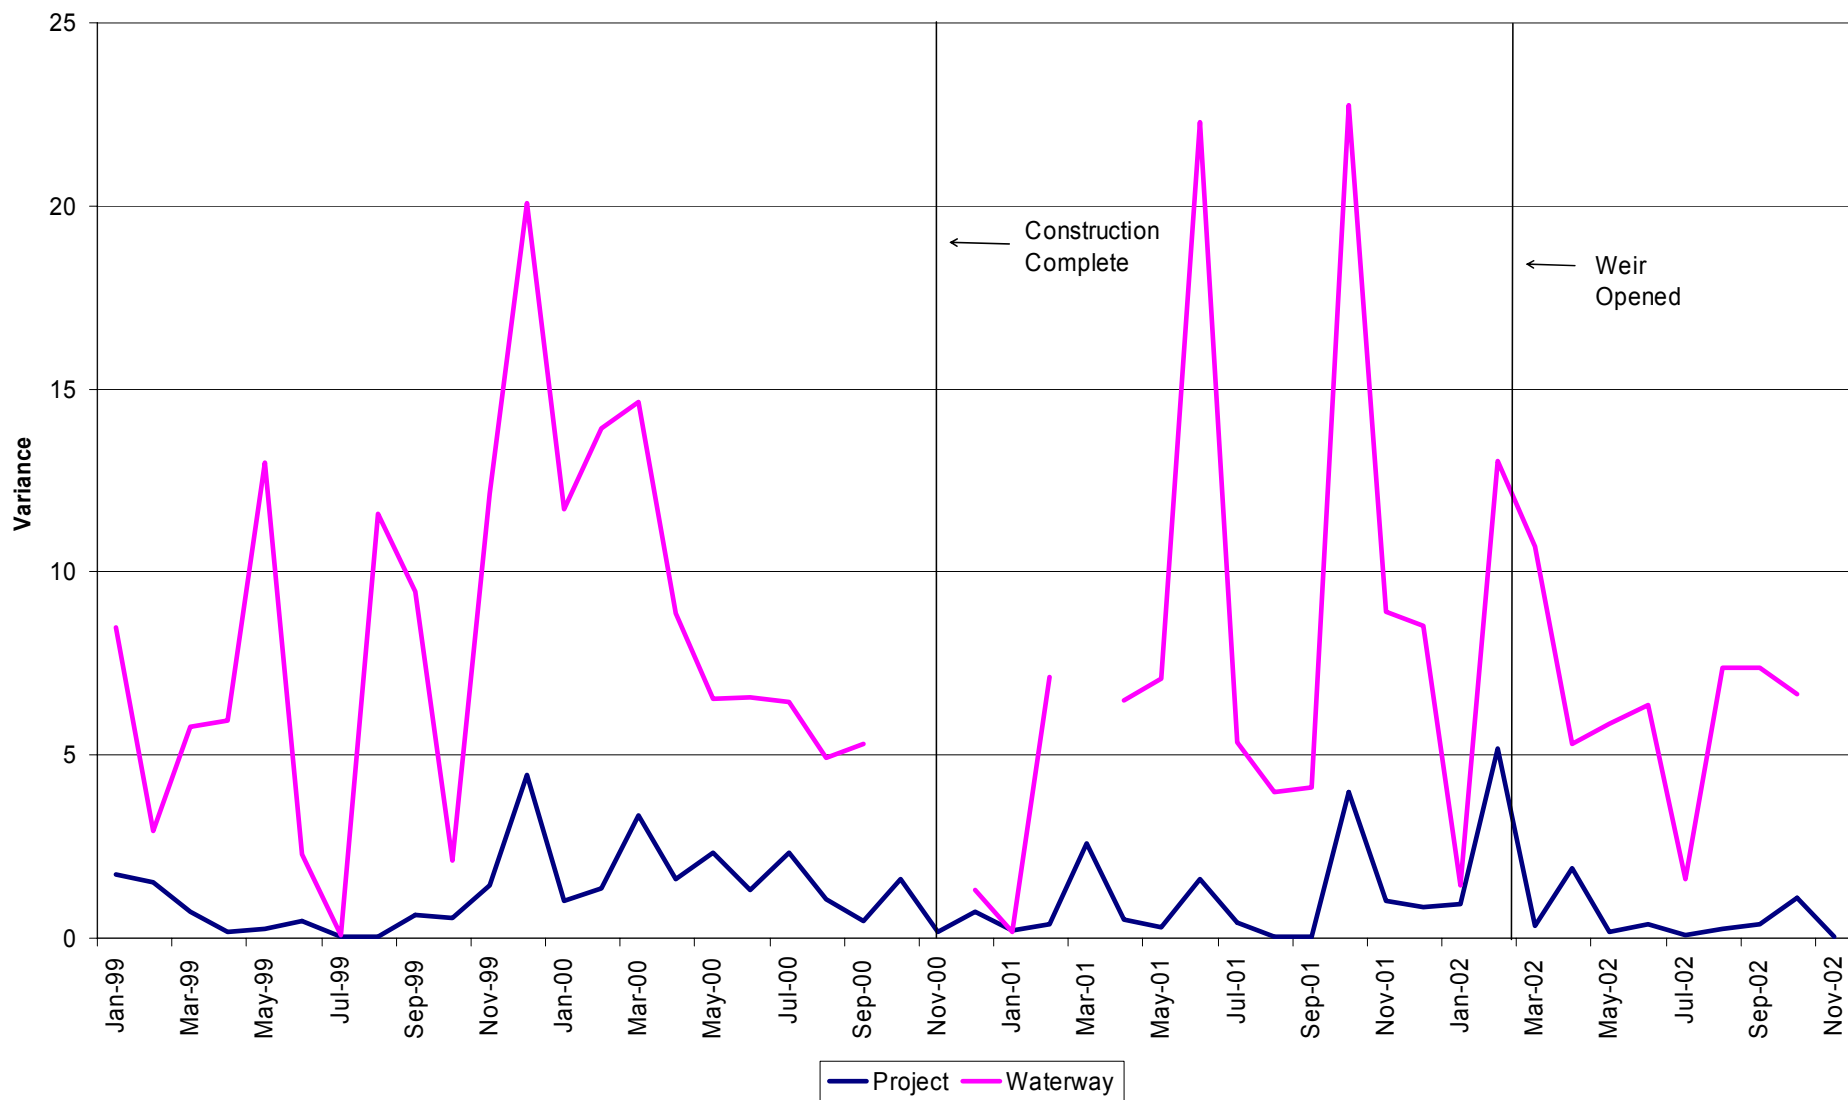
Monthly Variance in Salinity Measured at the Barataria Bay Waterway West Side Shoreline Protection Project (BA-23) from January 1999 - July 2002

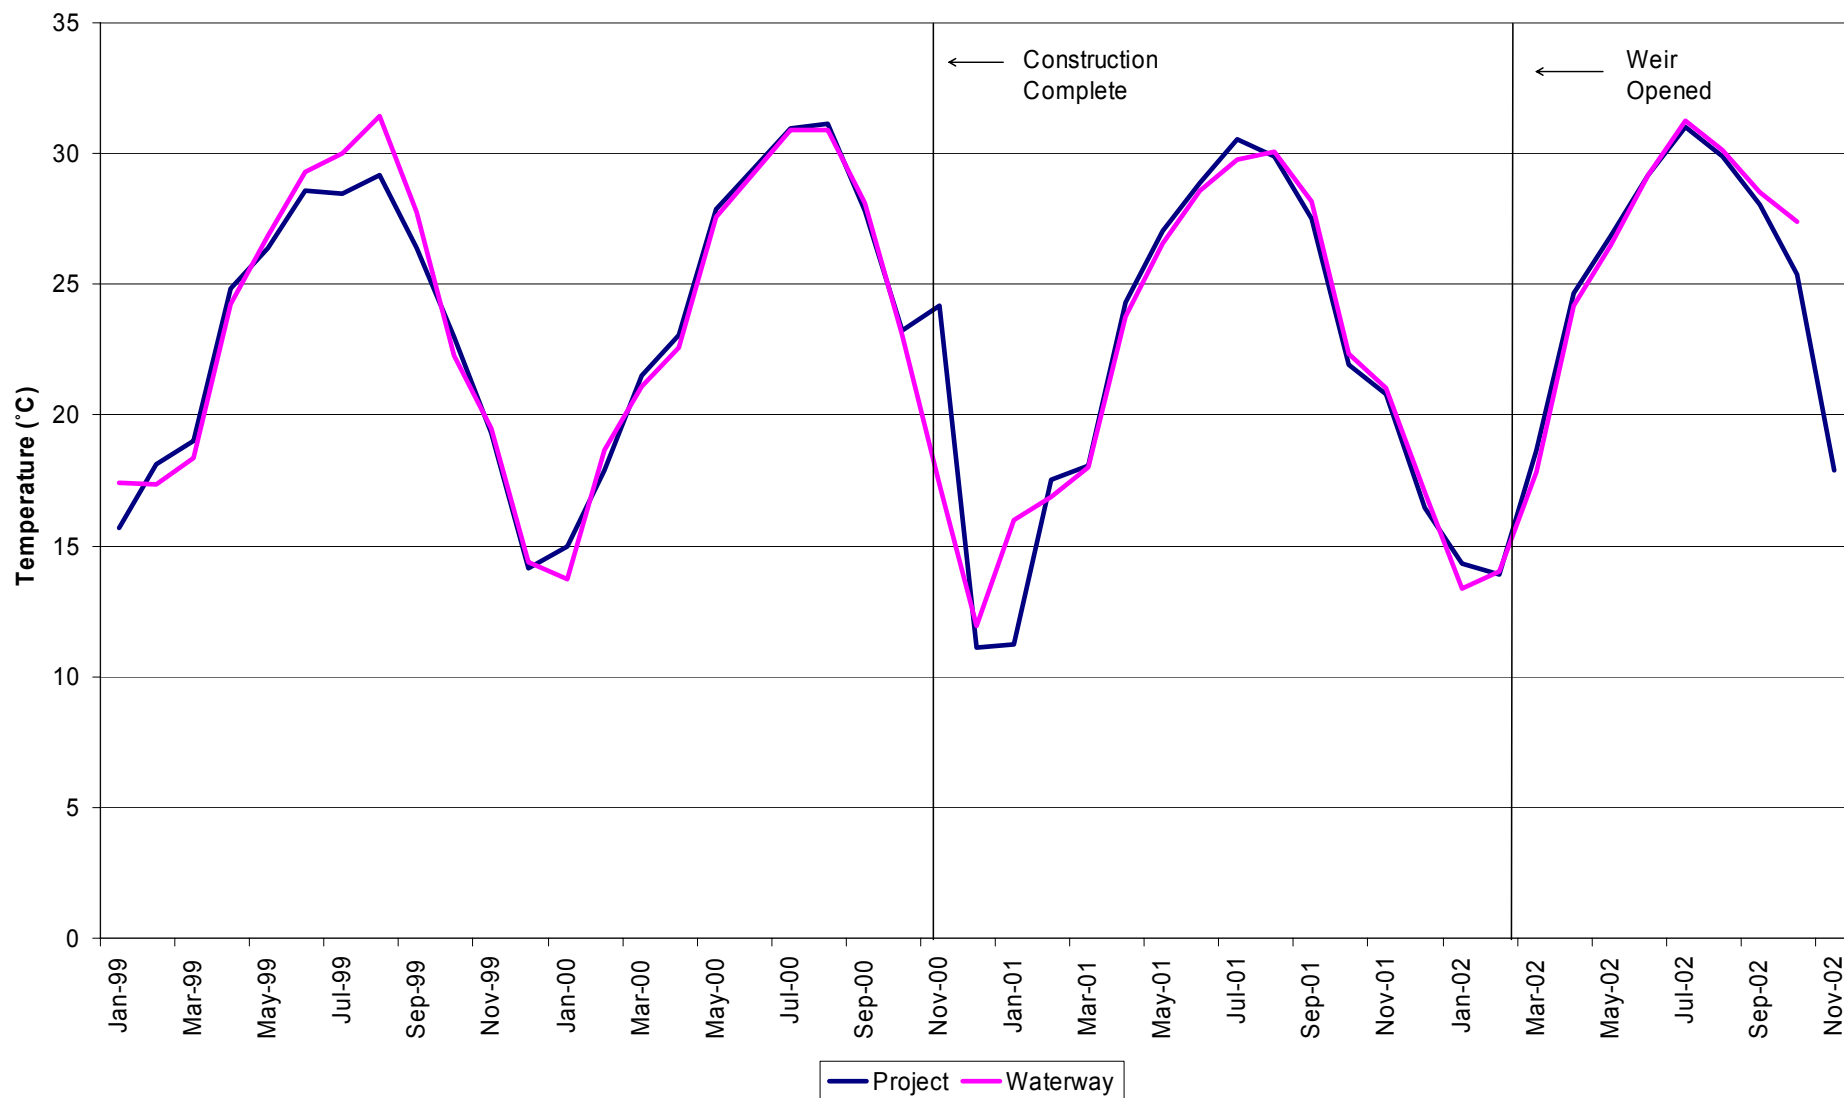
Monthly Average Water Column Temperature vs Time Measured at the Barataria Bay Waterway West Side Shoreline Protection Project (BA-23) from January 1999 - July 2002

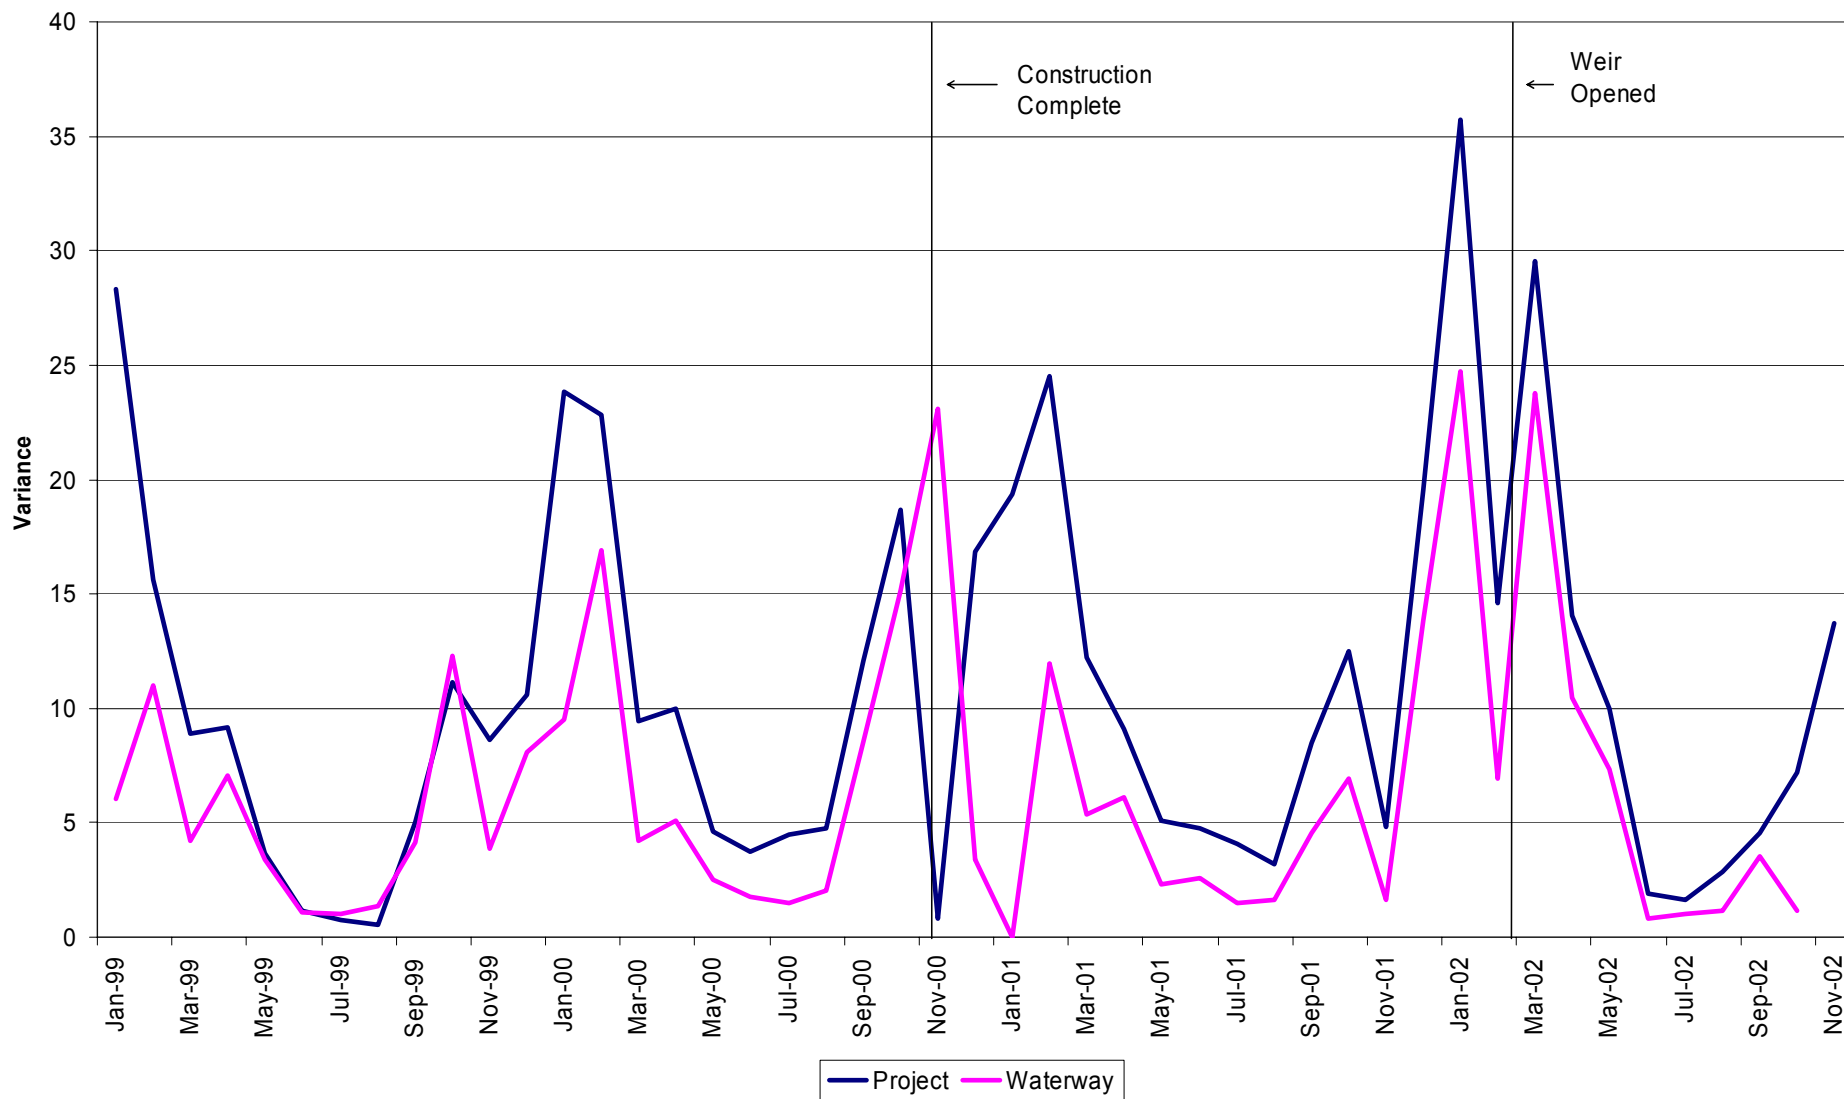
Monthly Variance in Water Temperature Measured at the Barataria Bay Waterway West Side Shoreline Protection Project (BA-23) from January 1999 - July 2002

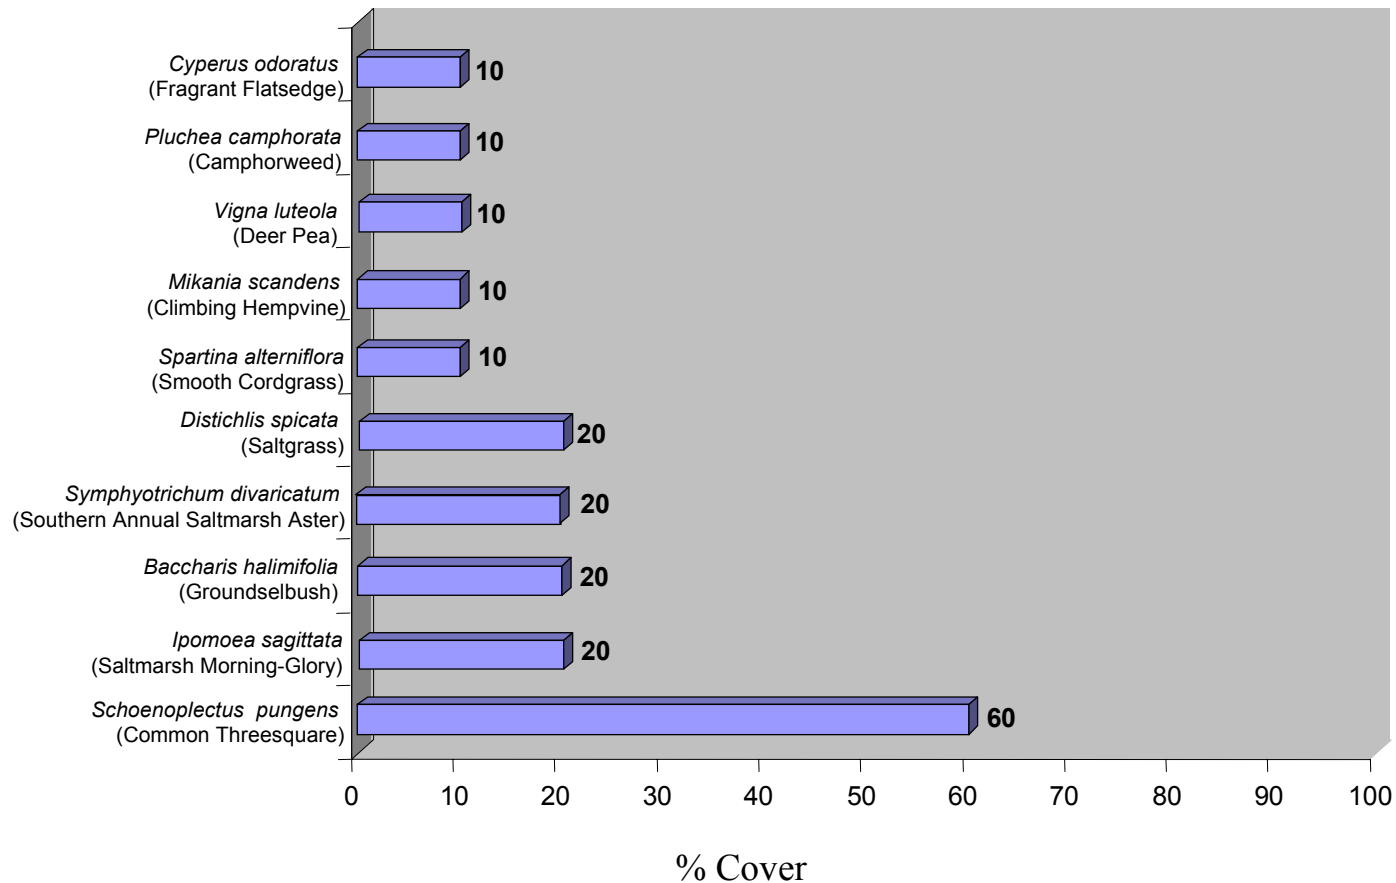
**Vegetation Data (Percent Cover) for the Barataria Bay Waterway West Side Shoreline Protection Project
Station BA23-101
November 1997**
